## **Close Out Documents**

### **AP-73 – 4600 Clayton St.**

Asbestos Abatement and Structural Demolition

## **Structure Survey Assessment Report AP-73**

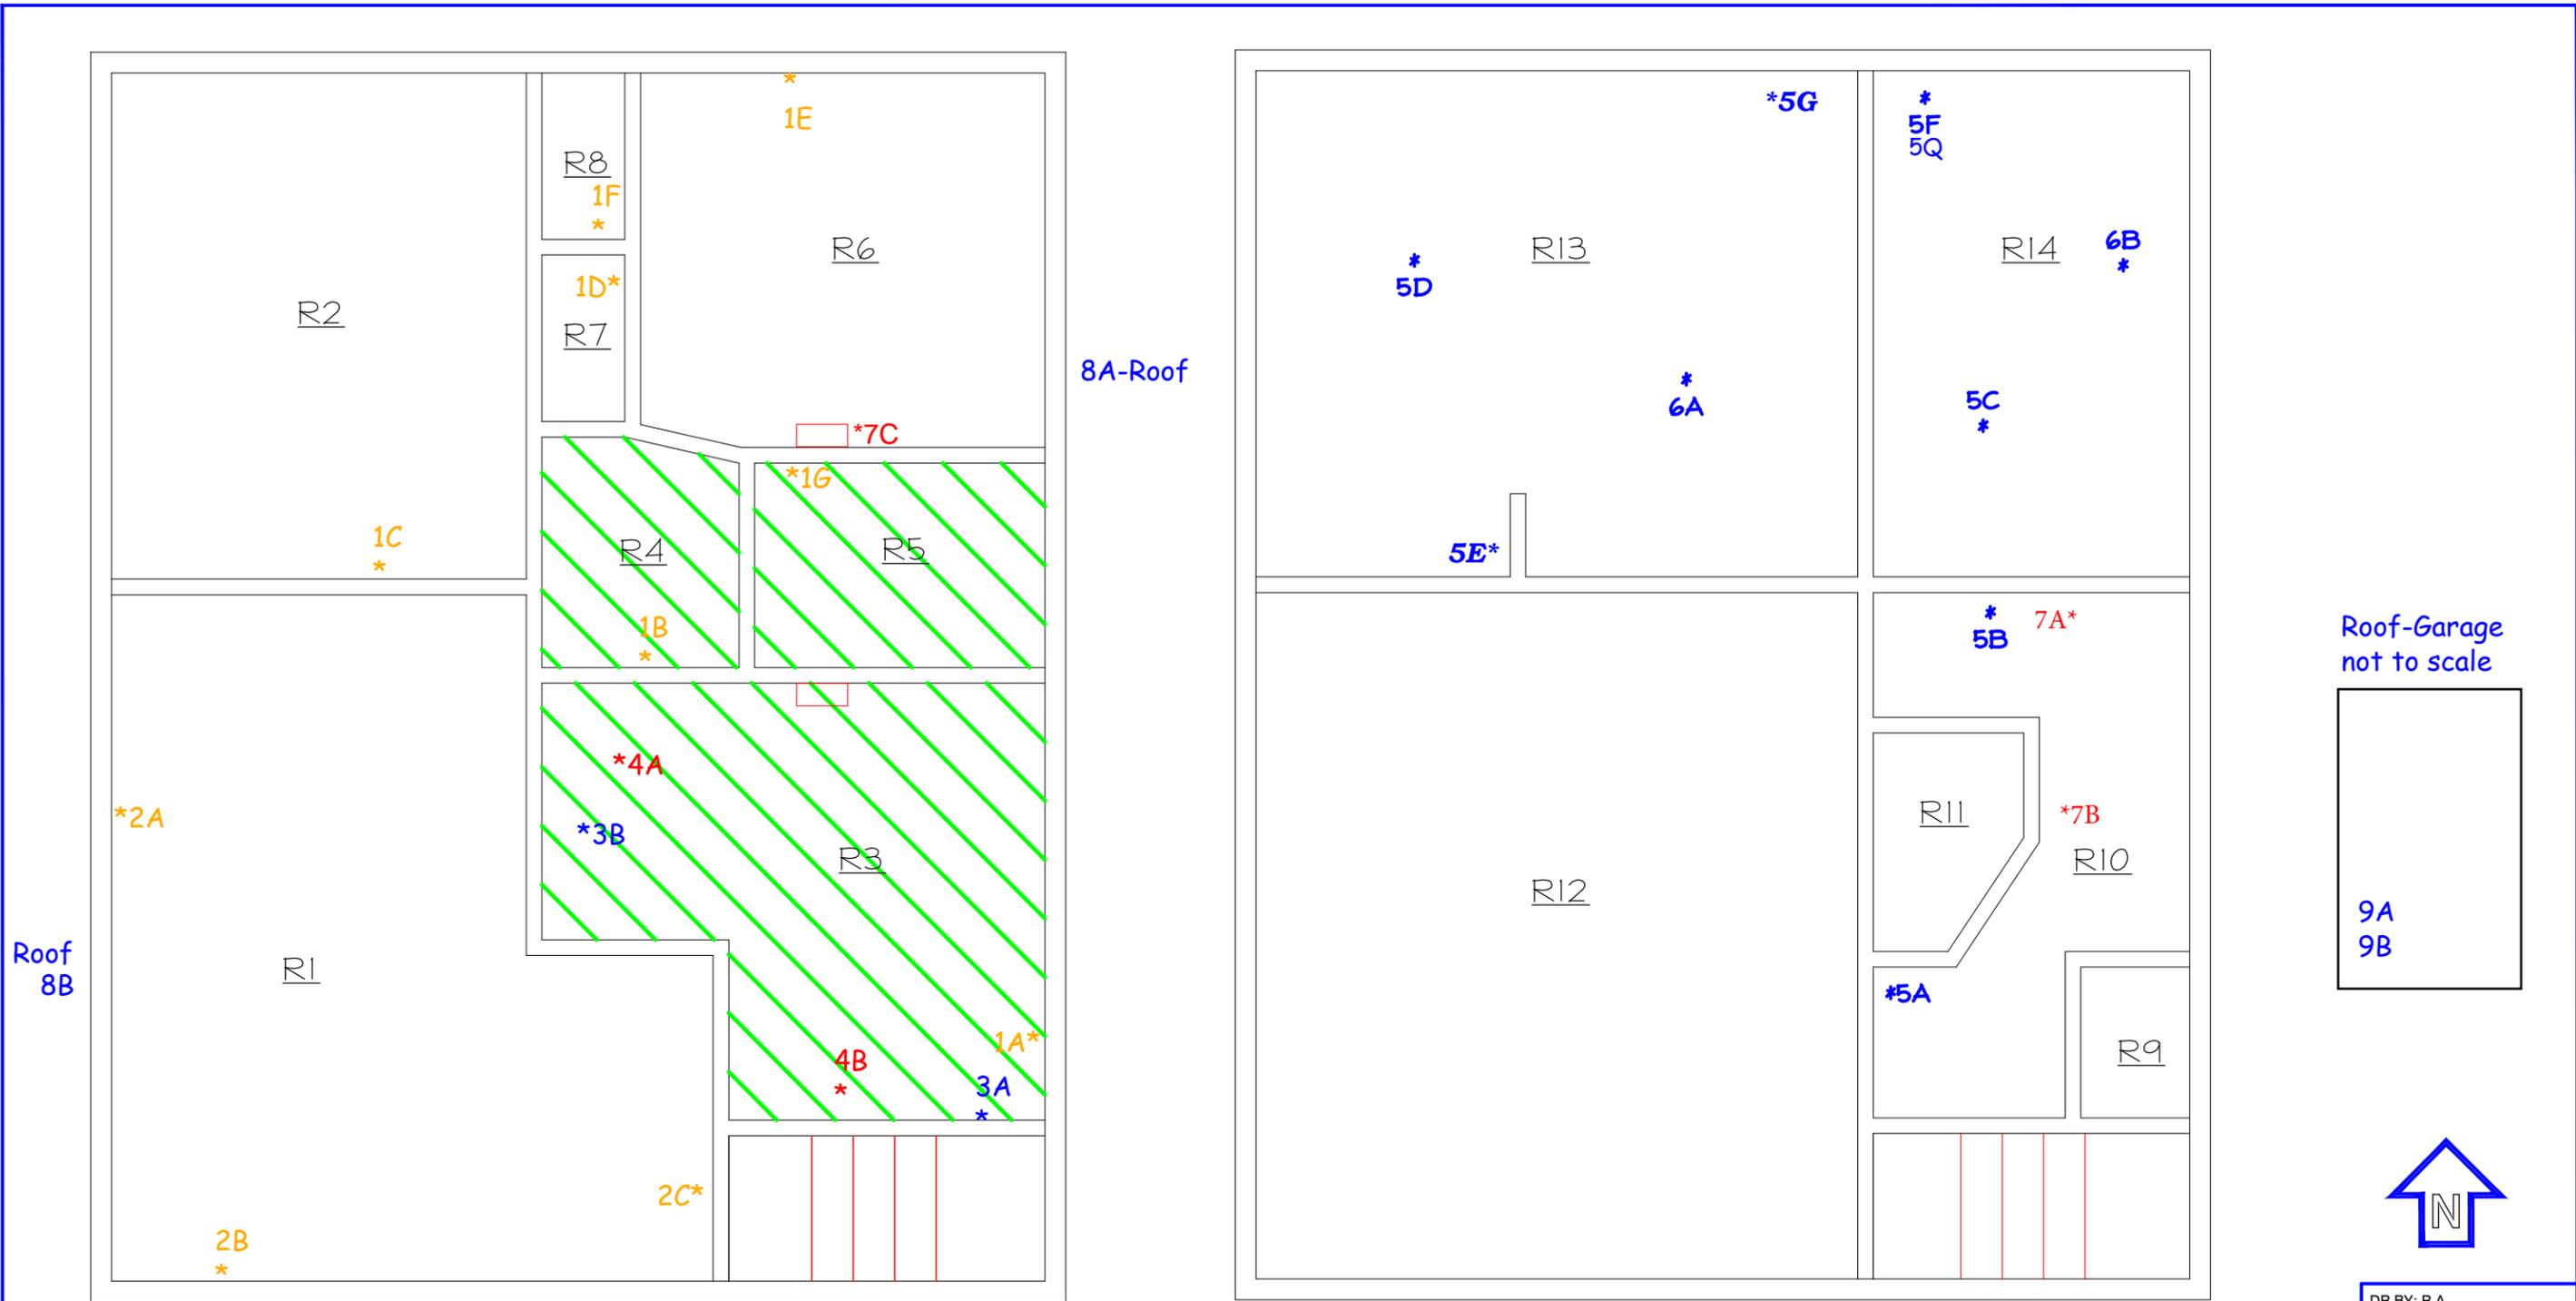
**FIGURE 2 - Asbestos Bulk Sample Locations**  
**CENTRAL 70 - Structure Survey Assessment Map**  
**AP-73**  
 4600 Clayton Street, Denver, CO  
 April 18, 2018  
 APEC #: 18-3066

On April 18, 2018 and August 2, 2018 APEC certified personnel Logan Greenfield conducted an asbestos survey for demolition at 4600 Clayton Street, Denver, CO 80216. The asbestos survey (inspection/sampling) was completed in accordance with the SSAP and follows guidelines established under the EPA's Asbestos Hazard and Response Act (AHERA) program and as required by USEPA regulation 40 Code of Federal Regulations (CFR) Part 61, National Emissions Standards for Hazardous Air Pollutants (NESHAP). Bulk sampling of suspected ACMs was performed in strict accordance with AHERA sampling procedures detailed in 40 CFR 763.86. These include but aren't limited to labeling each sample, recording each sample on a chain of custody, taking a photo of the sample and recording the location on a site diagram. Demolition work could disturb materials that contain asbestos and put unprotected workers at risk, violating asbestos regulations, which are enforced by the Occupational Safety and Health Administration (OSHA), the EPA, the Colorado Department of Public Health and Environment (CDPHE) and the Denver County Health Department. All samples were collected and submitted to EMSL Analytical, Inc. in Denver, CO per APEC chain of custody protocol. The laboratory is a member of the National Voluntary Laboratory Accreditation Program (NVLAP) and is qualified to perform the required analysis (Appendix A). The analysis conducted was the EPA Interim Method for the Determination of Asbestos in Bulk Samples, using standard Polarized Light Microscopy (PLM) and dispersion staining as established in 40 CFR Part 763.

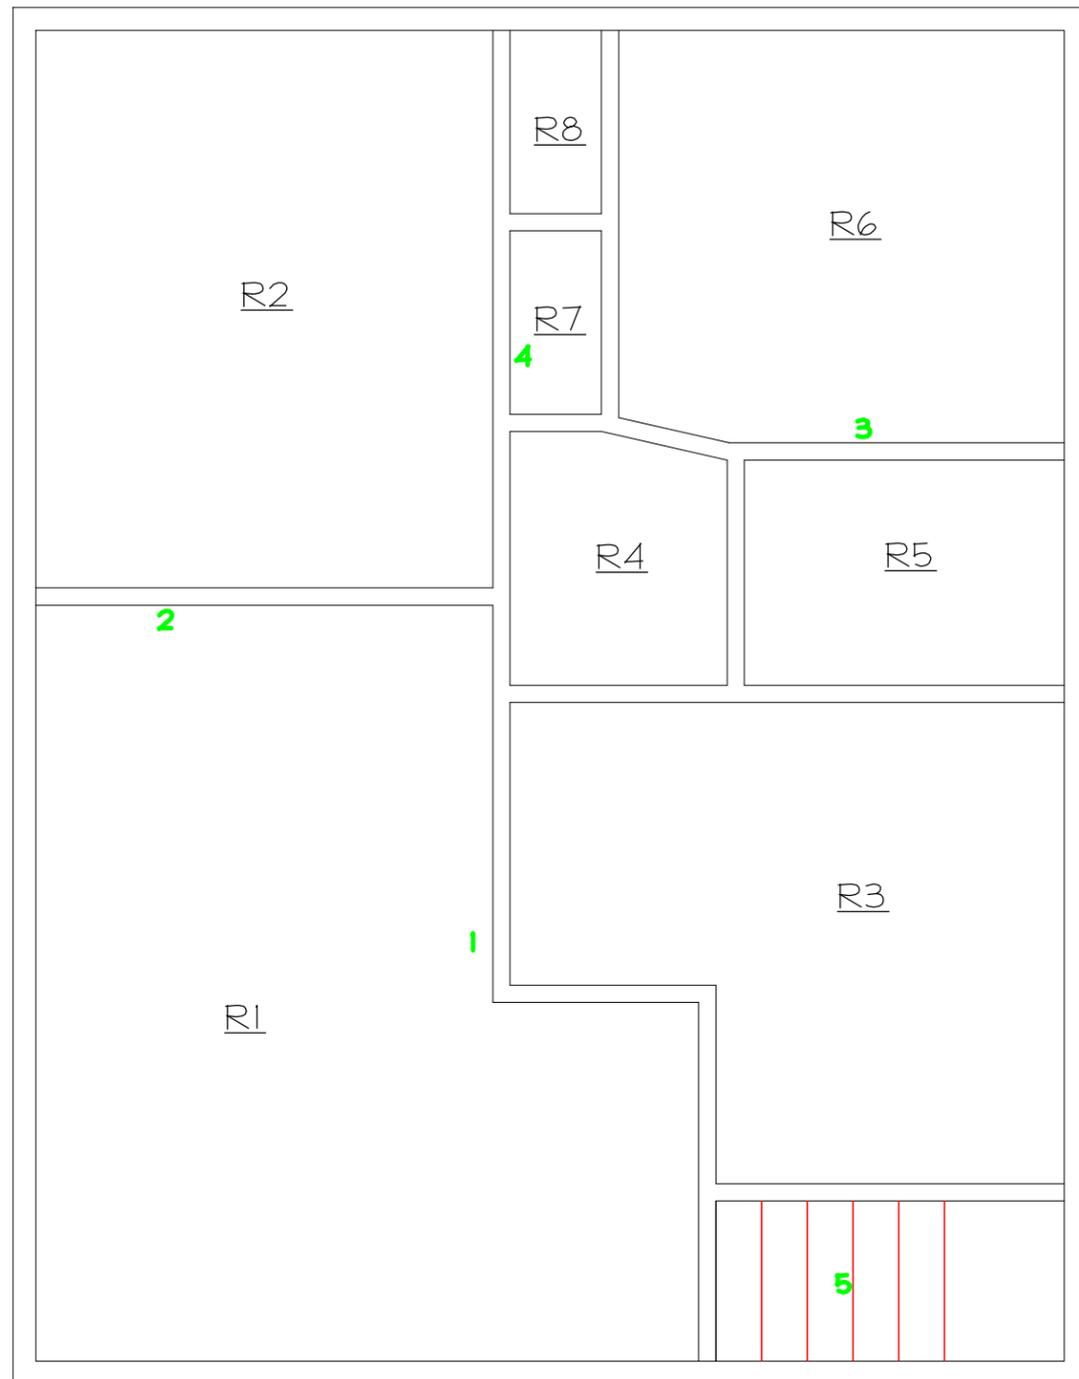
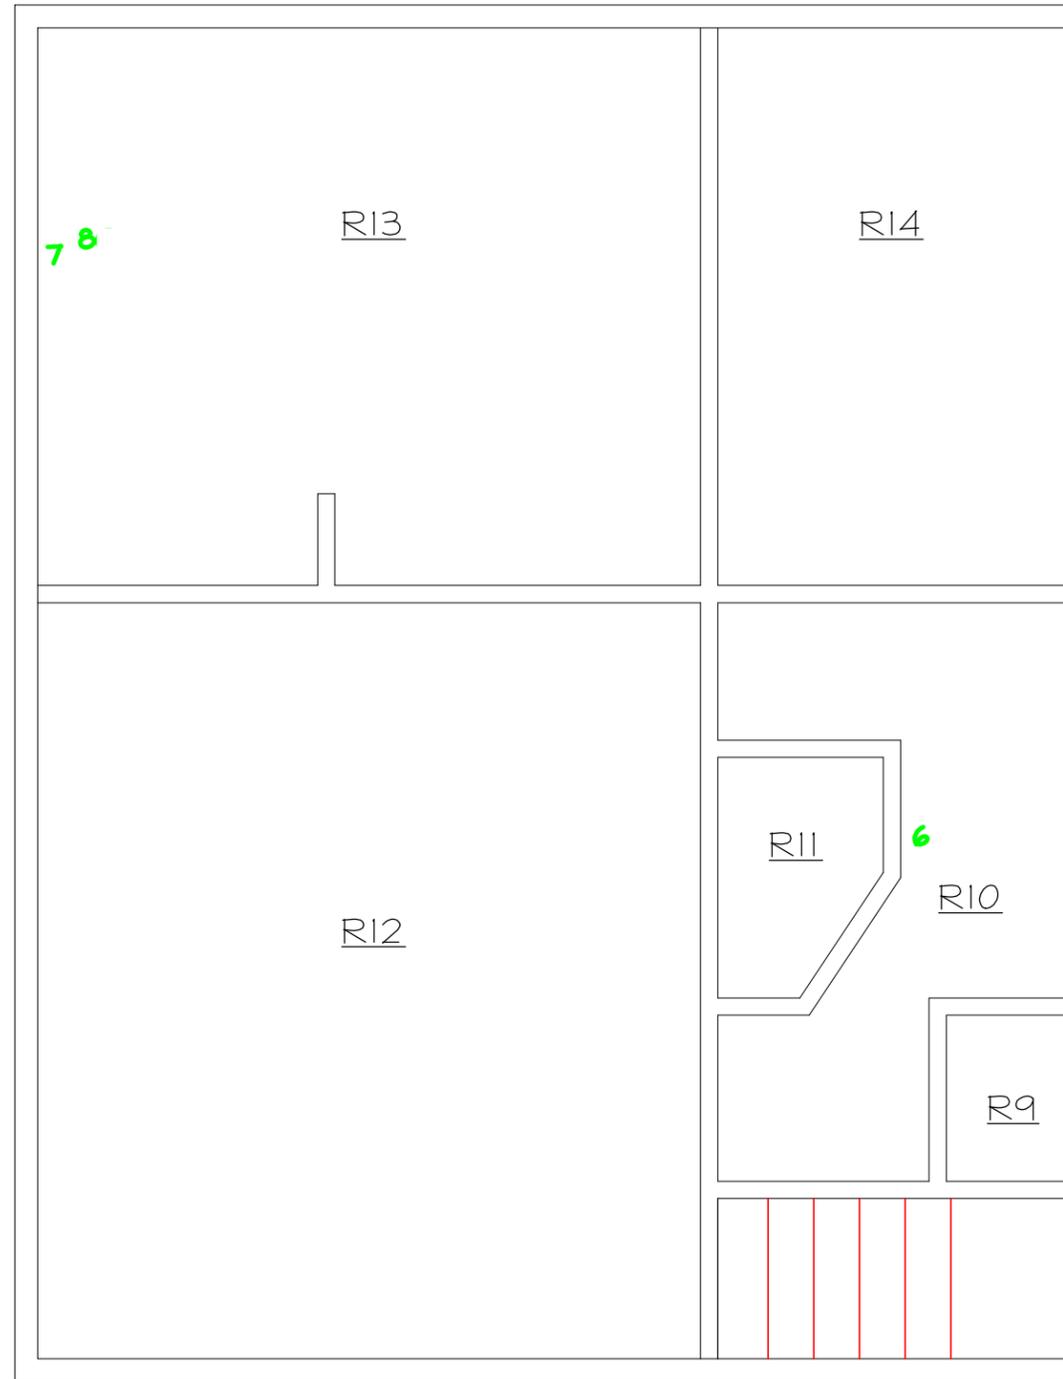
**FIGURE 3 - Lead-Based Paint Sample Locations**  
CENTRAL 70 - Structure Survey Assessment Map  
**AP-73**  
4600 Clayton Street, Denver, CO  
April 18, 2018  
APEC #: 18-3066

One lead sample (4600-Garage-11) result was found to be greater than 0.06% by weight and less than 0.5% by weight and is considered LCP (Table 4). The remaining 10 sample results were less than the LCP and LBP thresholds, and are considered non-lead containing paint (NLC). The laboratory analytical report is included in Appendix D.

- R1 = Room Numbers
- 4 = Lead Base Paint (Detect)
- 4 = Lead Containing Paint (Detect)
- 4 = Lead Base Paint (Non-Detect)

While the TCLP results indicate that the waste stream is not characteristically hazardous with respect to lead content, LCP is still present in the building materials. Therefore, the contractor responsible for demolition of this structure is notified with receipt of this report of the presence or potential presence of LCP and/or LBP in the building materials that comprise the building. The contractor should also notify their employees of the presence of LCP prior to any disturbance, and make the US Department of Labor Occupational Safety and Health Administration publication number 3142-12R 2004 available to their workers. (“Lead in Construction”, <http://www.osha.gov/Publications/osh3142.pdf>). The standards address topics such as permissible exposure limits (PELs) for workers, exposure assessment, protection of employees during assessment of exposure, employee notification, PPE, medical surveillance, along with other topics related to working with LCP and LBP.

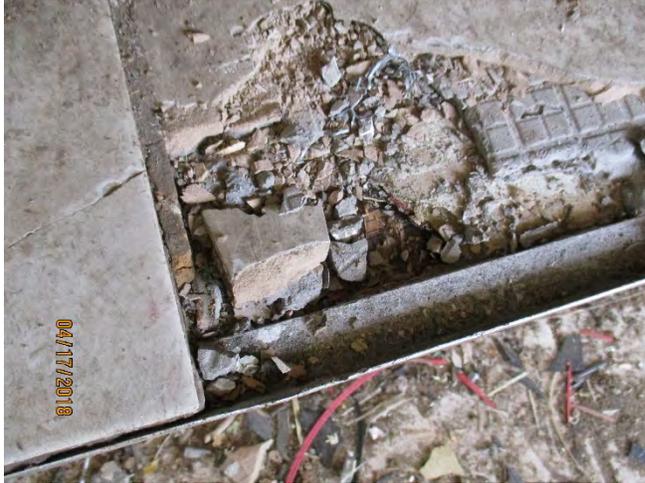
Floor Tile

Samples Represented –  
4600CL-R3-4A  
4600CL-R3-4B

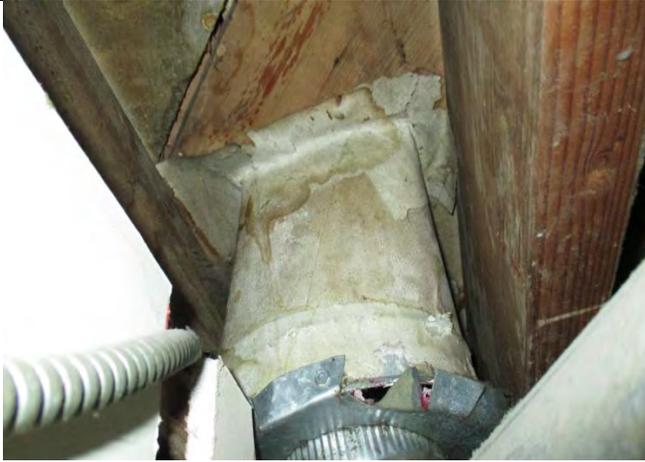
Duct Wrap

Sample Name	Sample Location	Lab Results/ Asbestos Type	Detection Method(s)	Condition	Material Description	Material Location	NESHAP Classification	Estimated Quantity (Sq. ft.)
4600CL-R6-7C	ROOM 6	DUCT WRAP 80% CHRYSOTILE	PLM	Good	DUCT WRAP	REGISTERS IN ROOMS 3 & 6	RACM	10

Samples Represented –  
4600CL-R10-7A  
4600CL-R10-7B  
4600CL-R6-7C

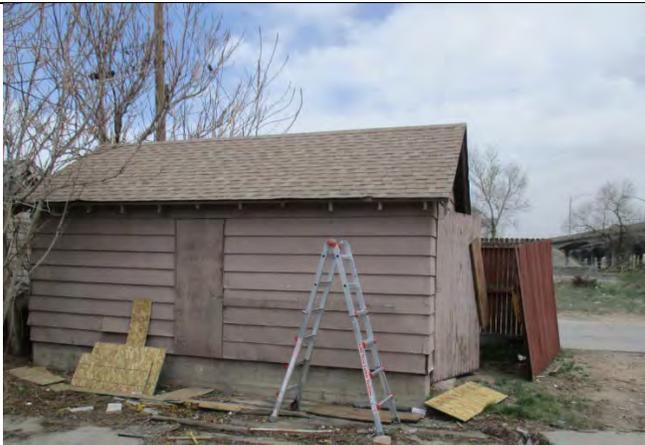
Exterior Garage Paint - LCP

Sample Represented –  
4600-Garage-11

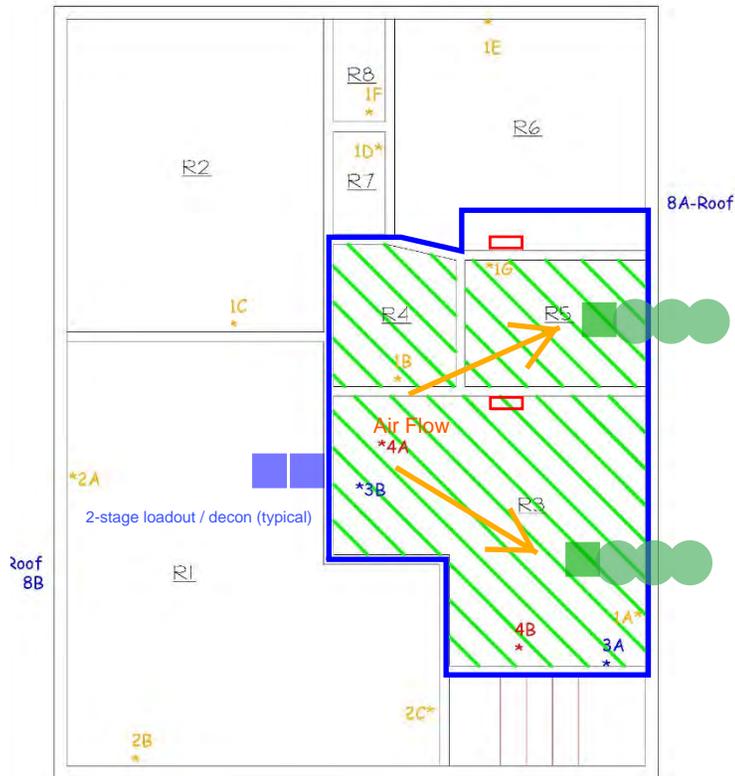
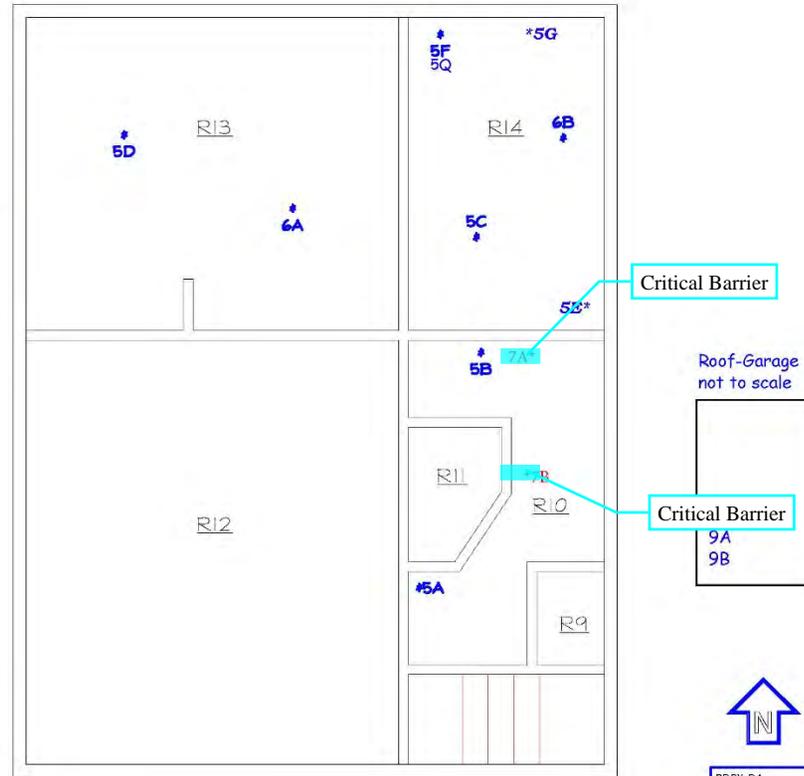
## ABATEMENT IN SECONDARY CONTAINMENT (12/10/18 -12/21/18)

- MAIN FLOOR PLAN**
- = Positive Asbestos at Floor
  - = Vent Boot Wrap Positive for Asbestos (10A & 10B)
  - R1 = Room Numbers
  - 4B = Asbestos Samples (Detect)
  - 4B = Asbestos Samples (Non-Detect)
  - 4B = OSHA Regulated Samples (1% or less)
